Tayloe House Architectural Report, Block 28 Building 3 Lot 262 & 231

Howard Dearstyne

1952 &
1953

*ARCHITECTURAL REPORT
THE TAYLOE OUTBUILDINGS
Block 28—Colonial Lots 262 & 231*

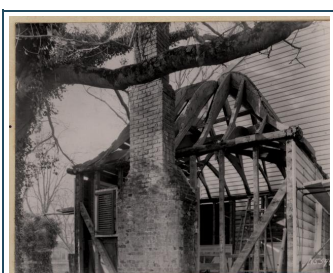
THE OFFICE DURING ITS RESTORATION. THE ROOFING AND THE WEATHERBOARDING OF TWO WALLS HAVE BEEN REMOVED, REVEALING THE INTERESTING STRUCTURAL FRAMEWORK OF THE BUILDING

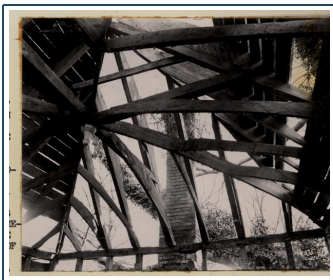
VIEW OF ROOF FRAMING FROM WITHIN THE OFFICE, MADE DURING THE RESTORATION OF THE BUILDING IN THE LATE 1930'S. THE PLASTER CEILING HUNG ON THIS FRAMEWORK HAD THE APPEARANCE OF A SHALLOW GROIN VAULT.

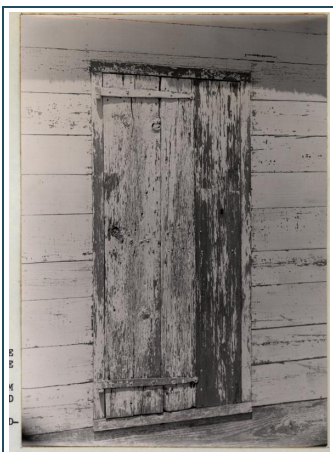
MUCH WEATHERED OLD DOOR OF SMOKEHOUSE. THE STRAP

HINGES ARE OLD AND AN OLD WOOD ENCASED RIM LOCK IS ATTACHED TO THE INSIDE FACE. THE BUILDING HAD BEEN WHITEWASHED.

Little was done, apparently, in the two decades intervening between this first restoration and the second, which took place in 1950, to keep the building in repair. It was left unwhitewashed; vines were allowed to envelop it so that the siding deteriorated from dampness, and dampness, caused by the fact that the earth on which the brick floor rested was level with the sill top, encouraged termites to settle in the sill and honey-comb with holes. A considerable replacement of wood parts was necessary, therefore, when the time came for the building to be re-restored.

As much of the old boarding was salvaged as possible, replacements being made where this was necessary. The south front was in the worst condition so that all of the boards on that face of the building, except the lowest one, have been replaced by new ones. All of the boards are old on the east face, except for the five lowest; on the north front they are all old or appear old, and on the west only three of the middle boards are old.

The only opening in the building is the old board and batten door on the south side which is placed about in the center of the façade and is raised 1'-2" off the ground (ills., pp. [184](#) and [192](#)). This is 6'-1" high and 2'-6" wide and swings out on a pair of old strap hinges nearly two feet long which pivot on pintles attached to the western stile of the frame. On the inside are three bevel-edged battens, above the center one of which is an old rim lock, 6" x 9" in size, which was found in place. This lock is encased in wood, the front face of which has been decorated with an incised pattern. The door has weathered to such an extent that the graining of the pine boards stands out beautifully in relief.

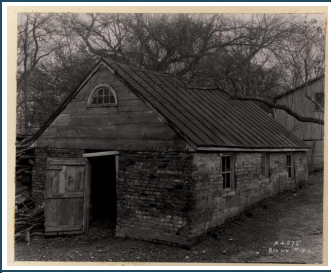
Certain facts of importance were immediately evident from the building itself. The plan shape and size were given by the existing foundations which, when measured, proved to be approximately 24'-9" long and 16'-5½" wide. The number and location of the basement "windows," that is, grilled openings, though altered in the nineteenth century, were still in evidence. The original size of these was apparent from the diverse character of the old and new brickwork and from the fact that the original brick sills were still in place, embedded in the masonry. (See ills., pp. [207](#), [208](#).) The openings were restored to their original size by the removal of the late brickwork. There are three such openings on the south side, the restored size of which is approximately 2'-3" by 3'-9". The present, restored size of the east basement window is about 2'-3" x 2'-11". There are no such openings in the basement walls of the north and west sides.

VIEW FOR THE SOUTHWEST OF THE TORSOLESS STOREHOUSE (THE MIDDLE STORY HAD BEEN REMOVED) BEFORE ITS RESTORATION WAS UNDERTAKEN IN 1950. THE BASEMENT OPENINGS REMAINED AND GAVE THE LOCATION OF THE PRESENT BASEMENT DOOR AND "WINDOWS."

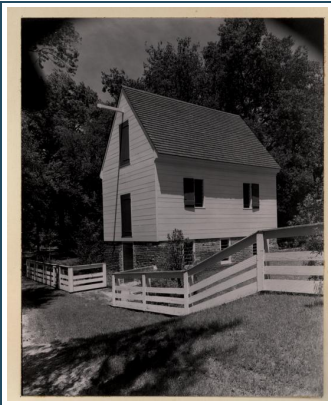
SOMEWHAT MORE DISTANT VIEW OF THE STOREHOUSE AFTER ITS RESTORATION, SHOWING THE SAME TWO SIDES OF THE BUILDING. THE FRAME SUPERSTRUCTURE WAS REBUILT ON THE BASIS OF EXISTING DOCUMENTARY AND PICTORAL EVIDENCE AS TO THE APPEARANCE OF THE OLD BUILDING.

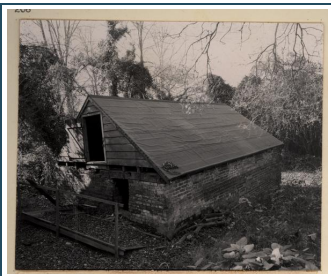
THE STOREHOUSE BEFORE ITS RESTORATION, AS SEEN FROM THE NORTHEAST. AN OLD "WINDOW" OPENING STILL EXISTED IN THE EAST WALL. IT WAS NOT BELIEVED THAT THE PATCHED AREAS IN THE NORTH WALL HAD BEEN WINDOWS, SO THAT NO BASEMENT WINDOWS WERE PLACED IN THIS WALL WHEN THE BUILDING WAS RESTORED.

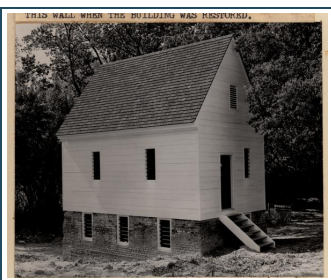
THE STRUCTURE VIEWED FROM THE SOUTHEAST FOLLOWING ITS RESTORATION. THE STEPS AND DOOR IN THE EAST WALL AND THE TWO FIRST FLOOR WINDOWS IN THE SOUTH FACE WERE PLACED IN THOSE POSITIONS ON THE BASIS OF STATEMENTS BY OLD RESIDENTS THAT THEY REMEMBERED SEEING THESE FEATURES IN THE OLD BUILDING.

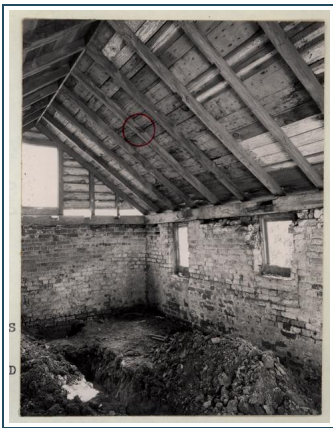
The second way in which the old framing affected the external appearance of the reconstructed building was in providing the means by which the pitch of the new roof was determined. It should be explained that the roof pitch at some period, probably at the time the height of the building was cut down, had been altered, the original rafters having been recut and reused. The roof pitch which obtained after the lowering of the building was about 37½°. That the pitch had at one time been greater was indicated by the existence in a number of the rafters of a notch or channel cut half way through the broad side of those rafters about 4'-0" from the roof ridge.

PHOTOGRAPH OF INTERIOR OF STOREHOUSE BEFORE ITS RESTORATION, LOOKING SOUTHEAST. ONE RAFTER NOTCH IS VISIBLE (IN RED CIRCLE), THE OTHERS BEING TURNED AWAY FROM THE CAMERA.
